## Chapter 6

# Investigation of Failure in Unidirectional Adhesively-Bonded Composite Joints via Infrared Thermography

Nithinkumar Manoharan and Suhasini Gururaja

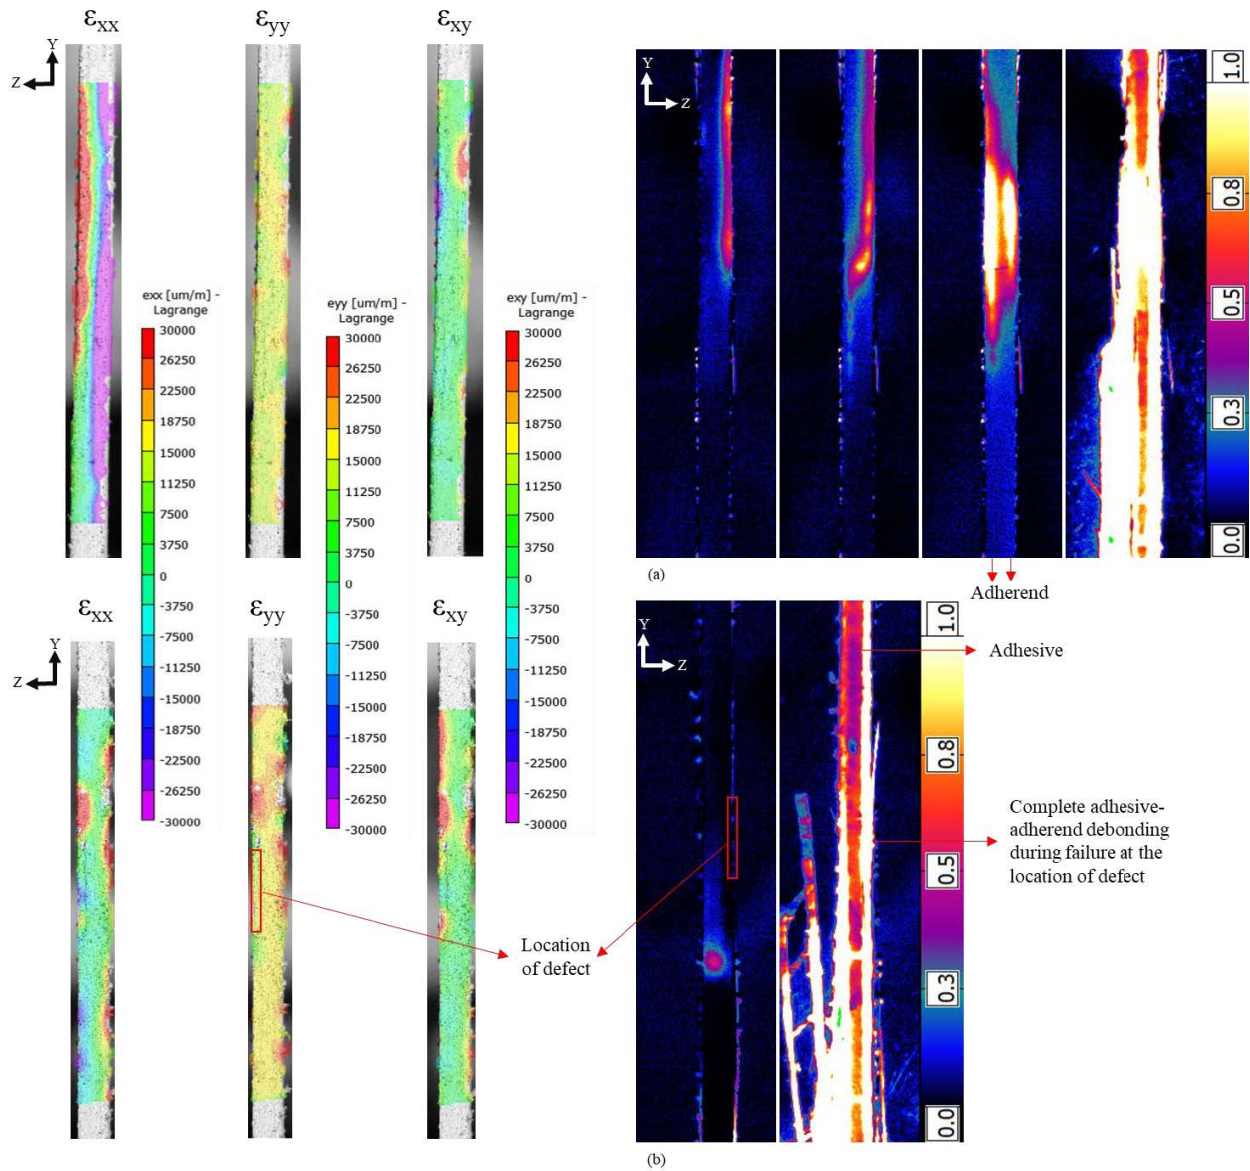
**Fig. 1** Full field microstrains before final failure and the thermograms showing change in surface temperature during failure (in  $^{\circ}\text{C}$ ) after image subtraction with initial state for (a) pristine, and (b) specimen with bondline defect under quasistatic tensile load

to improve the visibility of subtle temperature variations. Pristine specimens and specimens with bondline defect exhibited similar surface temperature behavior throughout the test, where the initial stages of loading showed a decrease in the surface temperature due to the thermoelastic effect, followed by a gradual increase as an indication of damage initiation, and a sudden spike (approximately 20°C in both configurations) during final failure.

The speckle pattern shown clearly distinguishes the adhesive layer from the adherend on either side. The transverse strain ( $\varepsilon_{xx}$ ) field showed a uniform distribution across each layer in pristine specimens, whereas a high strain concentration around the location of defect was seen in the other configuration indicating stress localization. Similar trends were seen when comparing the longitudinal strain ( $\varepsilon_{yy}$ ) contours, where a uniform strain distribution with high values of strain at the location of crack initiation could be seen in pristine specimens, suggesting a more progressive failure, while early stress redistribution around the location of the defect was observed in the defective specimen, leading to a sudden failure [10]. Shear strains ( $\varepsilon_{xy}$ ) showed high values at the interface region where the defect was placed, aligning with a complete interface debond with catastrophic failure at the same location (as seen in the thermograms).

A relatively uniform strain field, with uniform gradual damage accumulation leading to final failure with crack progression from the interface through the adhesive layer causing final failure via crack propagation was observed in pristine specimens. In contrast, specimens with bondline defects showed a non-uniform strain field with localized damage, resulting in sudden, catastrophic failure, highlighting the detrimental effects of even a small defect in the bondline.
