## Chapter 15

# The Great Train Disaster of 2025: Isolating Sensitive Equipment from Rail-Induced Vibration

**Abstract** Ground-borne vibrations from railroads are often assessed for their impacts on human comfort and vibration-sensitive equipment in nearby structures, but in rare cases, there is vibration-sensitive equipment located directly on the tracks and supporting structure itself. One such example is known as an Impedance Bond (Bond), which is a crucial component in railway signaling systems, particularly on electrified railways. It allows traction current to flow through the rails while simultaneously blocking the flow of alternating current (AC) used for signaling, ensuring both traction and signaling systems can operate independently and safely on the same track. Bonds typically have vibration criteria, which, due to the circuit boards in them that contain several delicate components, can be very strict at frequencies much higher than are usually considered for human comfort or typical vibration-sensitive equipment.

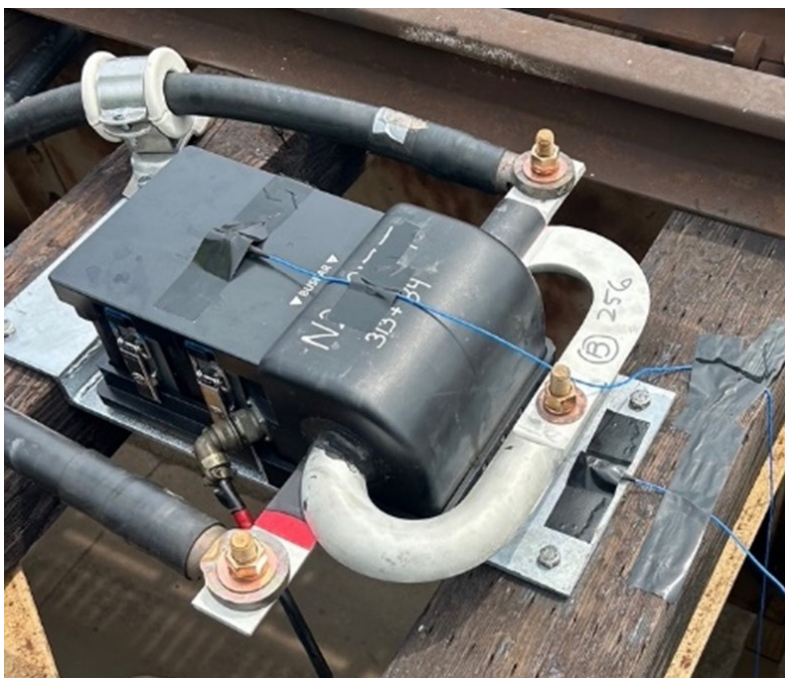
Impedance Bonds (Bonds) (example shown in Figure 1) are crucial components in railway signaling systems, particularly on electrified railways. It allows traction current to flow through the rails while simultaneously blocking the flow of alternating current (AC) used for signaling, ensuring both traction and signaling systems can operate independently and safely on the same track. These components are typically installed within the track gauge and are subjected to vibrations from passing trains, the intensity of which is influenced by local track conditions and mounting configurations, which usually include local vibration isolation systems. These isolation systems, which are provided by the Bond supplier as part of the overall system, are typically 3/8" neoprene pads that sit between the Bond the mounting frame below. Critically, the Bonds have bolts that penetrate the isolation pad that end with washers and nuts on the lower side of the mounting frame, which provides a destructive short-circuiting of the isolation system. The effects of this deficient mounting configuration will become evident throughout the course of this paper.

**Fig. 1** Typical Impedance Bond

- It should be noted that an additional potential isolation short-circuiting path may be present in the system through the electrical cables that connect the Bonds to the tracks (which can be seen in Figure 1). It was decided to conduct additional measurements at one location to quantify vibration transfer through the electrical cable connection. At this location, the measurements were first conducted with the cable connections to the Bonds (typical installation). In the second setup, vibration levels were measured at the Bonds without these cable connections in place.

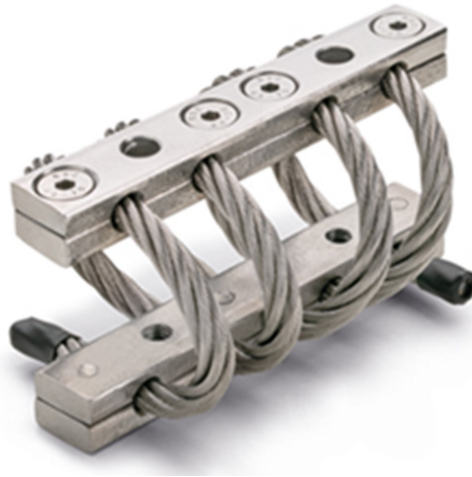
- The existing isolation details with 3/8" thick neoprene pad were also reviewed. Based on the assessment, an axial force of approximately 5000 lbs was predicted at the location of the bolts. This is expected to exceed the elastic load range of the 3/8" thick isolators. Therefore, in the vicinity of the bolts, the neoprene isolator is acting as a rigid connection, allowing transfer of vibration from the rail track to the Bonds. Also, it is noted that the bolts are not entirely resiliently decoupled. Thus, the currently installed isolators are not effective in mitigating vibration transfer to the Bond.
- Based on the conclusion that the existing isolation system was deficiently designed and installed, additional testing was then conducted to determine the efficacy of an alternative system, which was based on wire-rope isolators (example shown in Figure 6).

**Fig. 6** Wire Rope Isolator Example
